# Understanding the Causes of Nozzle Wear

Viper XPT-6000

## Causes of Nozzle Wear on the Viper XPT

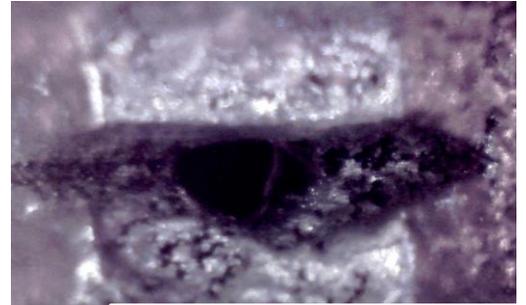
1. **Erosion:** Erosion is the gradual removal of nozzle material which causes the nozzle orifice and internal flow passages to enlarge. When this happens your spray pattern will change and additional pretreatment will be applied to the garment in comparison to when the tip was new.
2. **Corrosion:** Some pretreatments that are used in DTG printing are very highly corrosive. This can cause the nozzle material to wear internally as well as externally, enlarging the orifice and corroding the spray tip features causing irregular spray patterns.

This is a close up of a corroded or eroded spray tip which will cause irregular spray patterns.

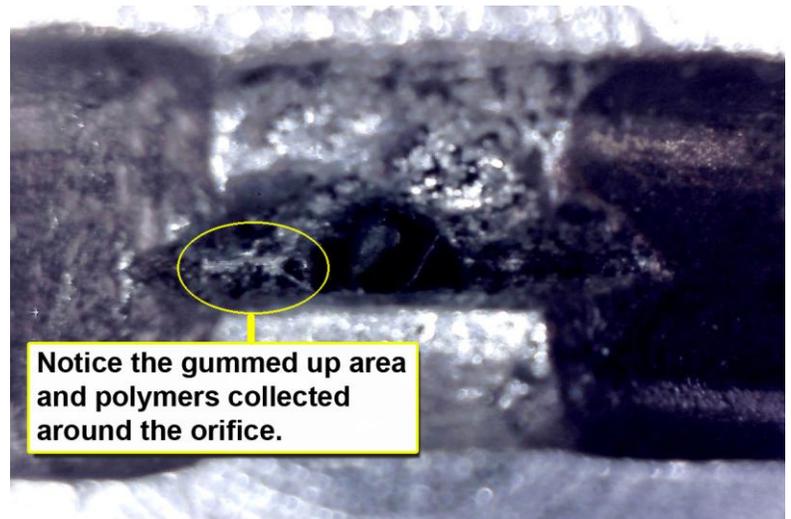
3. **Caking/Bearding:** This is the build-up of pretreatment material on the inside or outer edges of the orifice. Most typically if nozzle tips are not cleaned and flushed daily, pretreatment can dry and build up on the tips. Many times this is imperceptible to the naked eye, but this build-up can cause irregular spray patterns by obstructing the orifice and/or flow passages inside the tip.

Notice the gummed up area and polymers collected around the orifice.

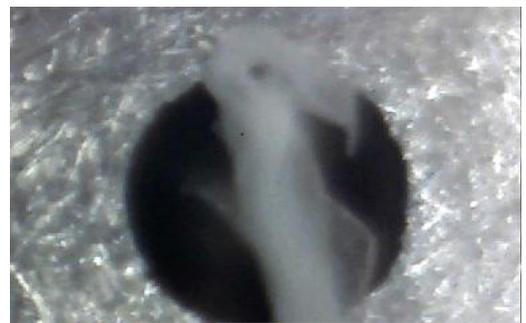
5. **Clogging:** Clogging is when unwanted solid particles block the inside of the orifice and cause distorted spray patterns. Most commonly what happens in the Viper is as the polymers in the pretreatment separate from solution they can collect and, when the Viper is sprayed are not able to be blown through the nozzle tip where it can collect causing a clog and a bad spray pattern.

Polymer build-up in the orifice is one cause of clogging.
